# Manhole Inspection Summary

Manhole # S25I\_\_036MH

Insp Date: **3/17/08 9:16 AM**

**Location** Address: **1324 W.PRATT ST.**

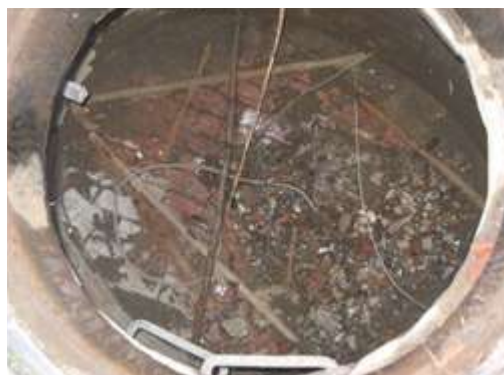
Defect 4

Comments **DEBRIS AT BOTTOM OF MANHOLE**

Condition: ☐ Sound ☐ Cracked ☐ Root Intrusion ☐ Deteriorated ☐ Leaks ☒ **Debris**

HEAVY DEBRIS AT BOTTOM OF MANHOLE

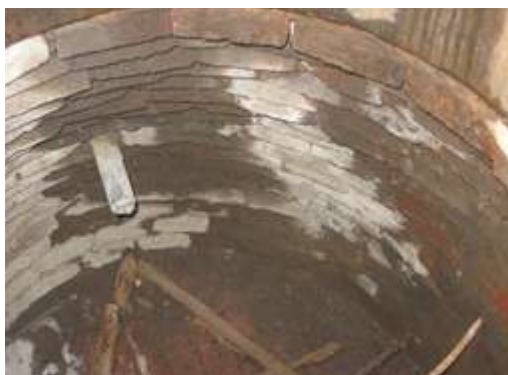
Defect 3

EVIDENCE OF INFILTRATION FROM THE CHIMNEY THROUGH THE CORBEL TO THE BARREL

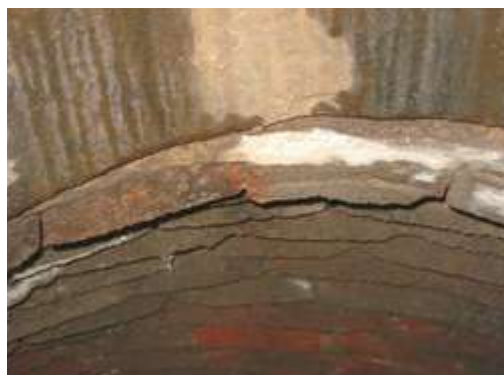
Defect 2

Infiltration: ☐ None ☐ Joint ☐ Cracks ☐ Mortar ☐ Roots ☒ **Wall**

EVIDENCE OF INFILTRATION AT THE CORBEL

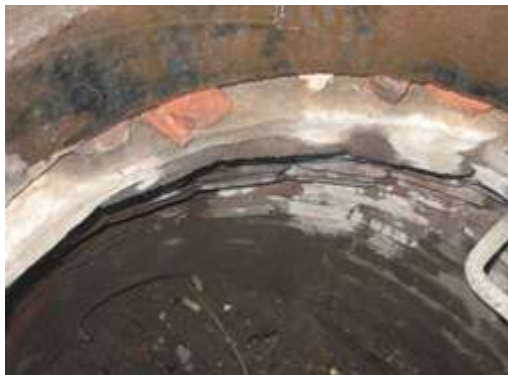
### Defect 1

Condition: ☐ Sound ☐ Cracked ☐ Root Intrusion ☒ **Loose Brick** ☒ **Deteriorated**

Infiltration: ☐ None ☐ Joint ☐ Cracks ☒ **Mortar** ☐ Roots ☐ Wall

MISSING MORTAR AND BRICKS WITH  
EVIDENCE OF INFILTRATION AT THE  
CHIMNEY

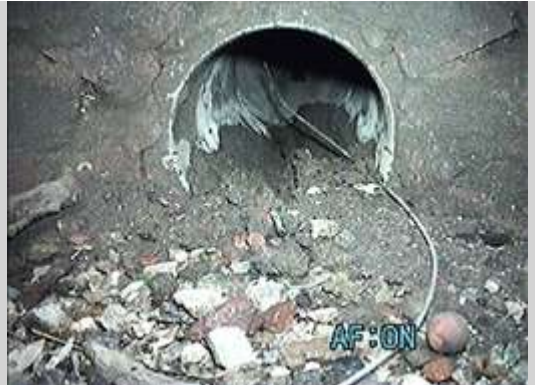
12 O'Clock Outflow

8 in. Circular Gravity Sewer  
Pipe Out @ 12 O'Clock

Pipe Height: **8.4** (in.) Rod and Bar (Angled)

Pipe Material: **Clay** ☐ Pipe Lined

Invert Depth: **5.20** (ft.) Flow Characteristics: **None**

Infiltration: **None** Pipe Seal Cond: **Sound**
